Service Bulletin

Number: #02-07
 Date: 10/11/2001
 Subject: SEA RAY EXHAUST INSTALLATION/VERIFICATION & SALT WATER INTRUSION PROCEDURES FOR 310DA, 340DA, 370DA, 380DA, 400DA, 410DA, (1999 TO 2001 MODEL YEAR WITH COLLECTOR STYLE EXHAUST SYSTEMS)
 Recall/ Bulletin
 Service Bulletin:

SUBJECT: SEA RAY® EXHAUST INSTALLATION/VERIFICATION & SALT WATER INTRUSION PROCEDURES FOR 310DA, 340DA, 370DA, 380DA, 400DA, 410DA (1999 TO 2001 MODEL YEAR WITH COLLECTOR STYLE EXHAUST SYSTEMS)

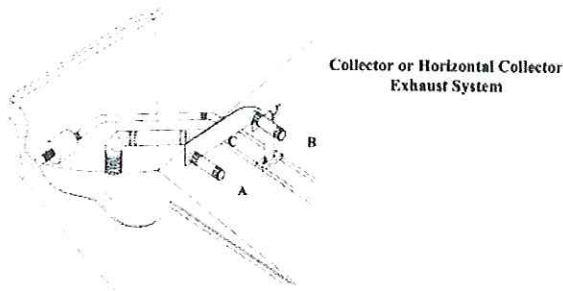
Exhaust System Illustration:

The system depicted above is representative of the type of system installed in Sea Ray® models for several model years. This system is often referenced as a *Collector or Horizontal Collector System*. Angles are extremely critical to this system. Note: All angles must be measured with a calibrated *Inclinometer* with the boat at static rest in the water.

Note: If you perform work in the bilge, or disassemble any of the exhaust components referenced above, it is your responsibility to ensure the angles are reestablished per the matrix 1A above. Failure to do so could result in an ingestion failure. If you need assistance, please contact either the Knoxville Customer Service Department at (800) 648-8535 or the Merritt Island Customer Service Department at (800) 648-2821.

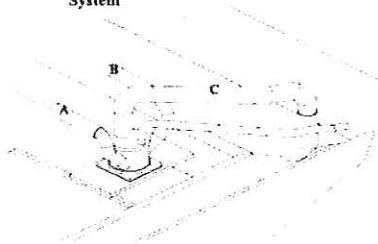
Water Lift Exhaust
System

The system depicted above is a *Water Lift Style System*. This system is now utilized in all of Sea Ray's gasoline v-drive and inboard models. This system is also a system governed by angles. Note: All angles must be measured with a calibrated *Inclinometer* with the boat at static rest in the water.

Note: If you perform work in the bilge, or disassemble any of the exhaust components referenced above, it is your responsibility to ensure the angles are reestablished per the matrix 1B above. Failure to do so could result in an ingestion failure. Again, please call either Merritt Island or Knoxville Customer Service if you need assistance.
