A REVIEW OF EXHAUST ELBOW EVOLUTION and RESONANCE REVERSION

Jane Christen, SAMS-AMS®

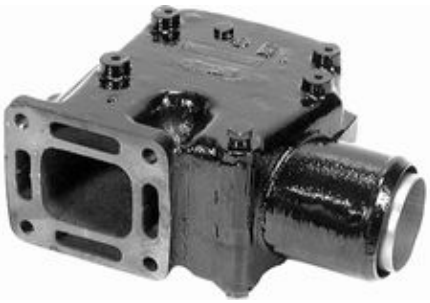
| <p>Photo 1.</p> | <p>P/N 98502A2 Fits MIE GM V-8 with center rise outlet exhaust manifold.</p> |

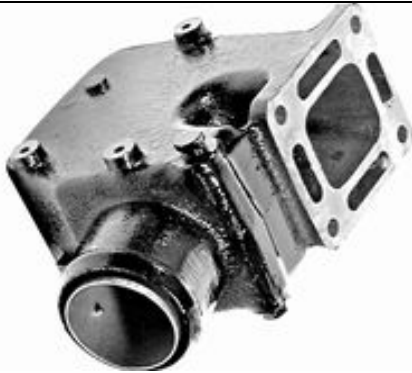
| <p>Photo 2.</p> | <p>P/N 98504A3 Fits MCM/MIE GM V-6 & V-8 engines with center rise outlet exhaust manifold.</p> |

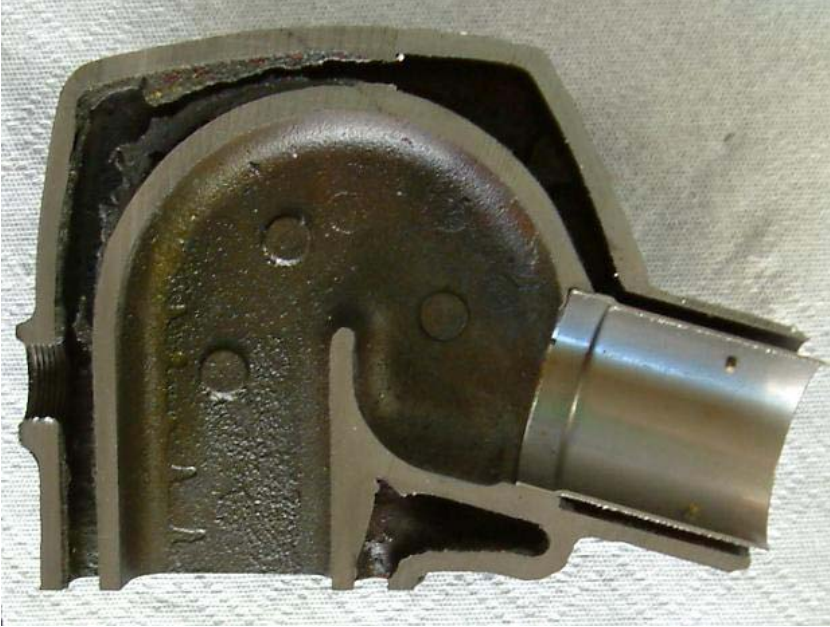
| <p>Photo 3</p> | <p>Upon slicing open p/n 98504A3 elbow, we found there is a very slight hook towards the exhaust discharge.</p> <p>This appears to be an effective design to prevent resonance reversion.</p> |

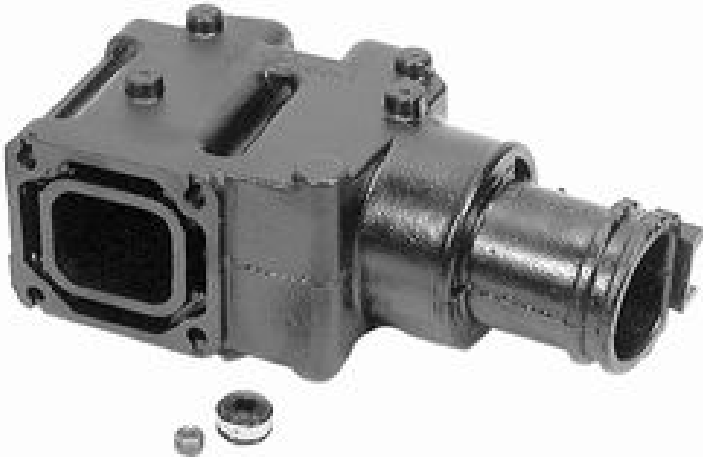
Next Generation: MerCruiser V-6, V-8 and Ski boat engines (excluding those using Gil style pipes, or high performance header and tailpipe) for the years of **1987 through 2002** are now using p/n 807988A2. This exhaust elbow appears from the superceded list to have been designed and put into use about 1998 with the 0L002000 and up serial number engines. P/n 807988A2 is also engineered for the earlier engines, and supercedes four (4) original part numbers on the 1987 through 1998 engines. The Bravo engines of this era originally offered stainless steel elbows (p/n 816900A5, 816900A7, 816900A9) which have all been discontinued. The stainless elbows and the cast iron elbows p/n 807988A2 were all designed to fit the same exhaust manifold, so the cast iron p/n 807988A2 is universal. **The design of this elbow is a major change, in that there is no apparent impediment for resonance reversion.**

| <p>Photo 4</p> | <p>P/N 807988A2 Fits MCM/MIE GM V-6 & V-8 engines with center rise outlet exhaust manifold</p> |

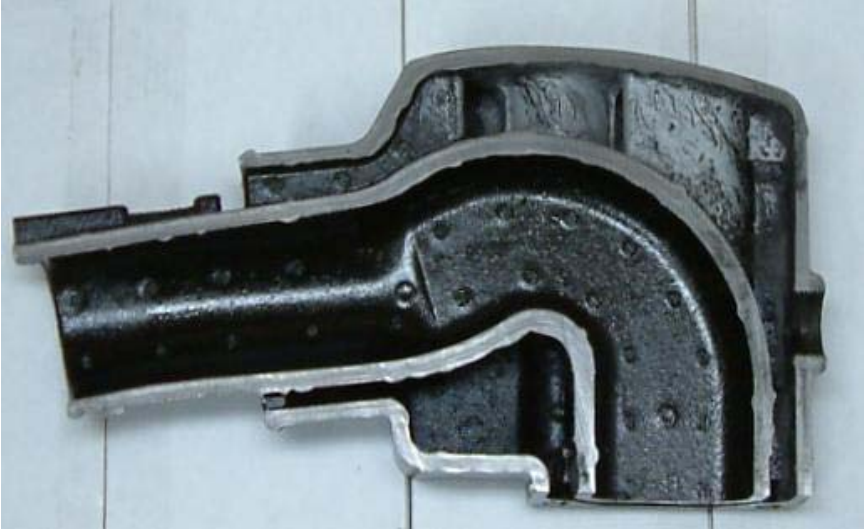
| <p>Photo 5</p> | <p>Upon slicing open a p/n 807988A2 elbow, it is immediately apparent how smooth a path is present for resonance reversion.</p> |

Our research, experience and anecdotal information indicates the introduction of exhaust elbow model p/n 807988A2 around 1998, occurred at about the same time as the electronically controlled engines with more aggressive valve overlap were introduced. The p/n 807988A2 elbow is a 4 inch O.D. with 7 degree down angle casting. This larger size was reportedly introduced for the higher horsepower engines, as everything prior was 3 inch O.D. with either 0 degree, 15 degree or 90 degree down angle.

While a re-designed exhaust elbow with an effective vacuum-break would be of significant help on new engines, the p/n 807988A2 elbow - which is almost universal for the last 15 years of engine production, is worthy of scrutiny. Attention to the complete system on engines of this vintage is prudent. Installation of a Resonator Kit may be beneficial. Maintenance of the internal shutters is also strongly suggested.

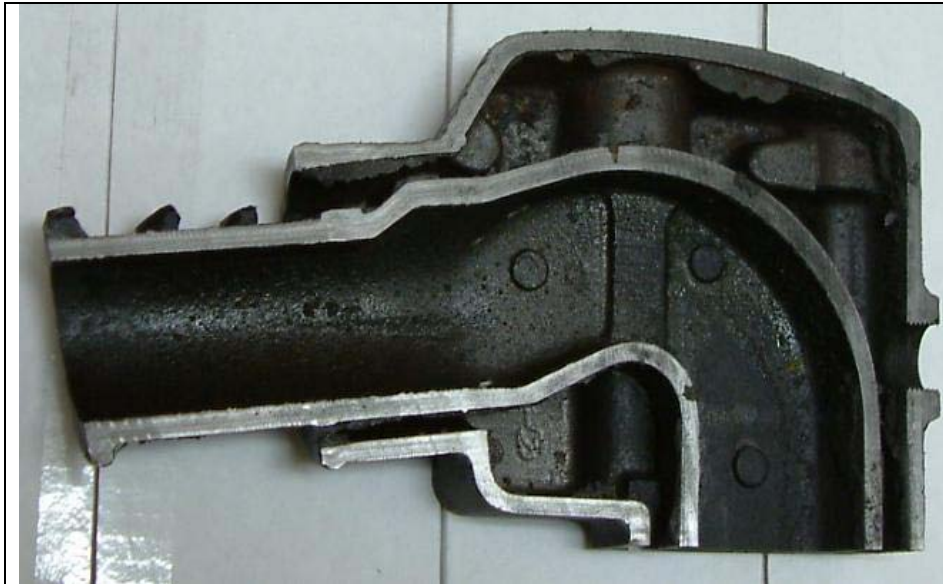
Photo 6

This is the elbow built by Osco for Boat/US. It is an “aftermarket” replacement for MerCruiser p/n 807988A2. It is Osco p/n 4354 and/or Boat/US p/n 274009

Note that this casting has a kink in the top line of the discharge that is not present in the MerCruiser model. Because the kink is in the top line, it appears this would be inadequate to prevent resonance reversion, although it will disturb the exhaust flow and possibly provide some help.

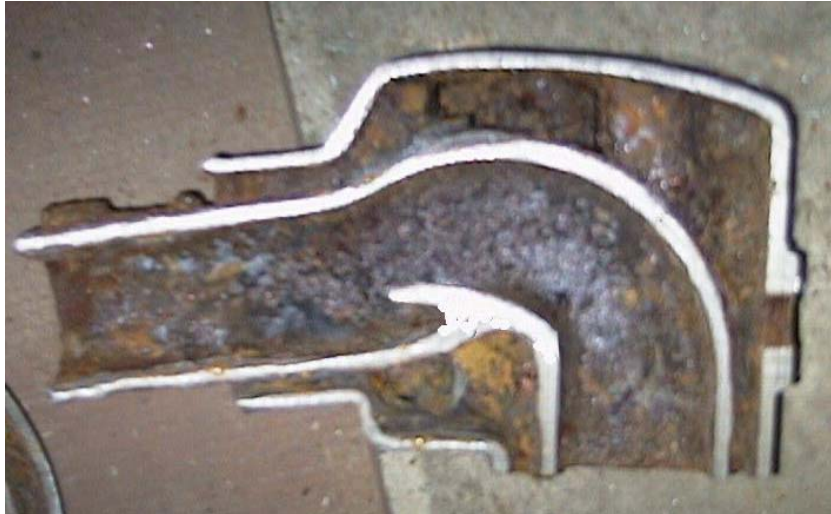
Photo 7. Example of "Vacuum-Break" hook drawn on photo.

The mechanic advised that it was his presumption this casting detail had been lost during redesign by a new crop of engineers that did not know the reason for the lip. He also advised that previously one of the standard diagnostic procedures when inspecting an engine that had suffered water damage was to reach into the back of the elbow and check on the status of the vacuum-break. He explained that this casting detail would eventually erode away from impingement, leaving the engine vulnerable to reversion.

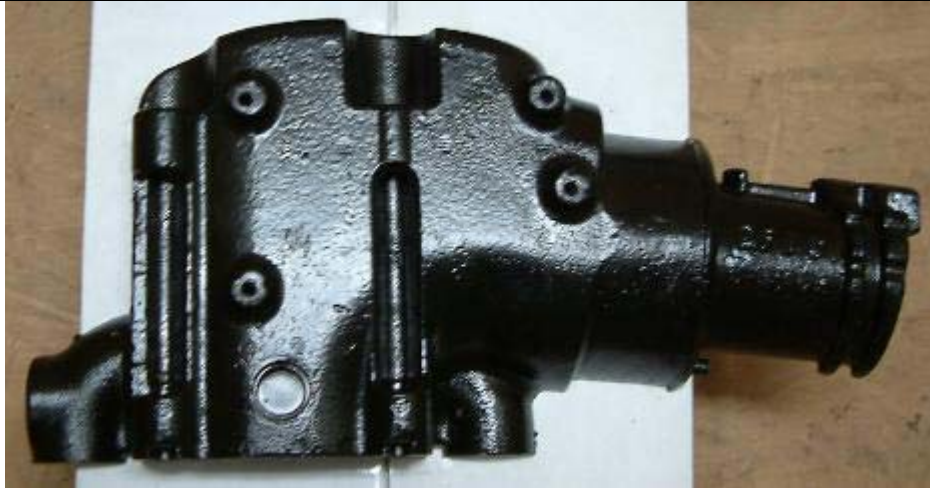
Photo 8

The p/n 864309T01 elbow is a “dry joint” elbow. Note the water passages buttressed around the exhaust joint where the elbow mounts on the manifold.

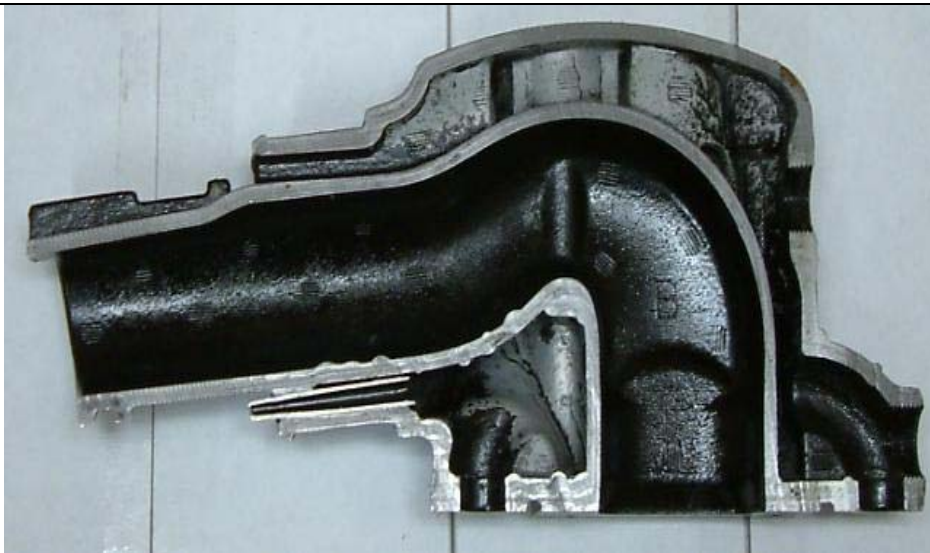
Photo 9

This elbow is essentially the same as p/n 807988A2 with the water loop added for the dry joint. There is a slightly irregular hump in the upper line of the discharge pipe. **No indication of an effective vacuum-break is observed.**

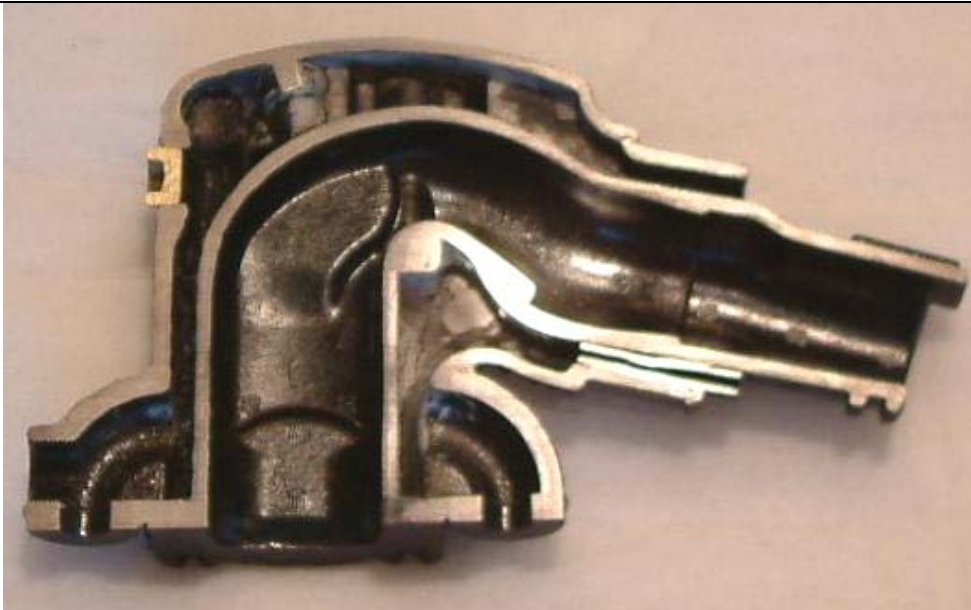
Photo 10

MerCruiser has introduced an exhaust elbow that includes a vacuum break. This is p/n 864591T02 and is listed for use on for MIE GM V-8 (350 & 377 cid) *inboard and ski boat* engines with dry joint exhaust manifold (2002 and newer) The specifications are 4 inch (102 mm) O.D., 14 degree down angle, Ceramic coated. It is unknown if the exhaust manifold p/n 865049T01 that is used with the “T01 and T02” elbows can be retrofitted to earlier model engines.

This is p/n 864591T02. The vacuum break casting detail is highlighted in the photo.

Dry joint elbow requires exhaust manifold p/n 865029T01.

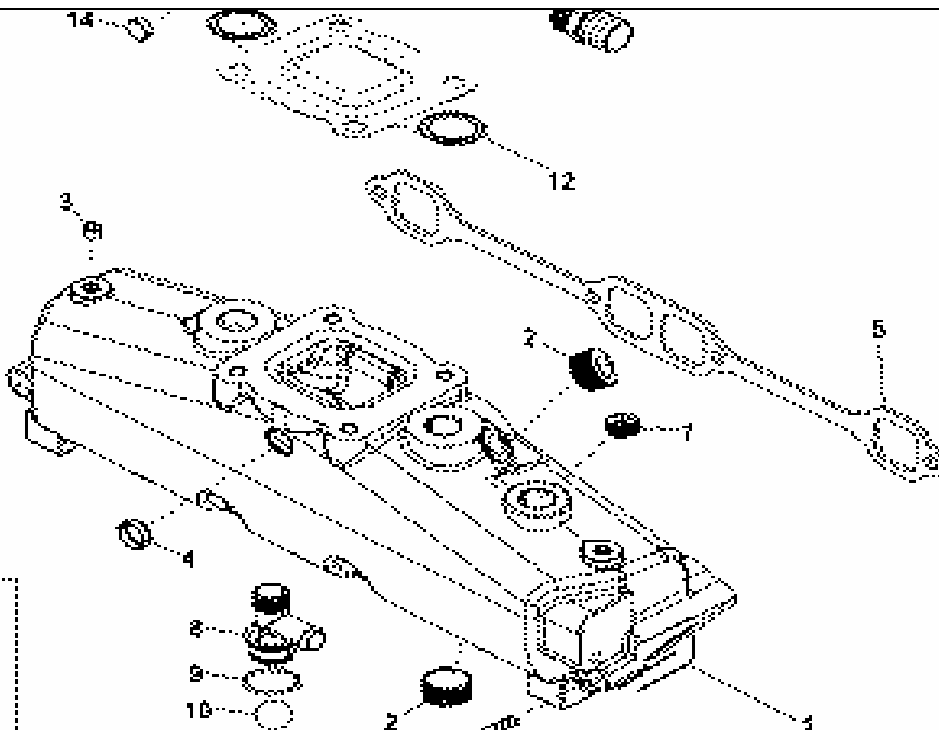
This is exhaust manifold p/n 865029T01. This manifold has the water connections for the dry joint exhaust elbows.
