Removing the Curved Seatback in a 280DA

The following are the procedures I used for removing the aft facing front port side seat back on a 2005 Sundancer 280. There are some posts about it from several years ago under “water-under-aft-berth-on-280da”, post #8, but the pictures are long gone and the poster is no longer active.

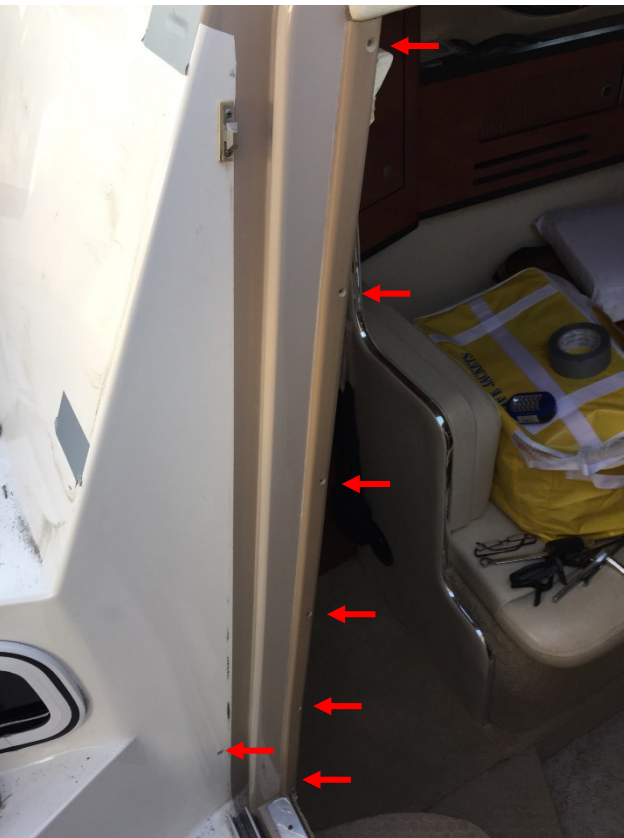
To start, #1 REMOVE THE CURTAIN (there is a retaining screw in the track that allows the sliders to come out).

#2, REMOVE THE CURVED, PADDED TRIM/VALANCE (there are 4 visible screws underneath plastic caps)

#3, REMOVE THE CEILING LAMP (4 screws visible once the lens is removed).

#4 REMOVE THE VERTICAL DOOR TRIM (see diagram screw locations, one is outside under a plastic trim cap)

#5 REMOVE THE INNER, UPPER TRIM PANEL inside the mirrored door immediately aft of the cabinet (the location of the audio amp). There are two visible screws to remove it).

#6, REMOVE THE FINISHING TRIM on the top of the cabinet.

Also, on the port lite over the cabinet, remove the aft-most securing dog by taking out the single phillips screw. Note the black spacer underneath the dog as you remove it. This needs to come off for clearance to slide the trim panel with the light switch on it enough to access the securing bolts for the seatback.

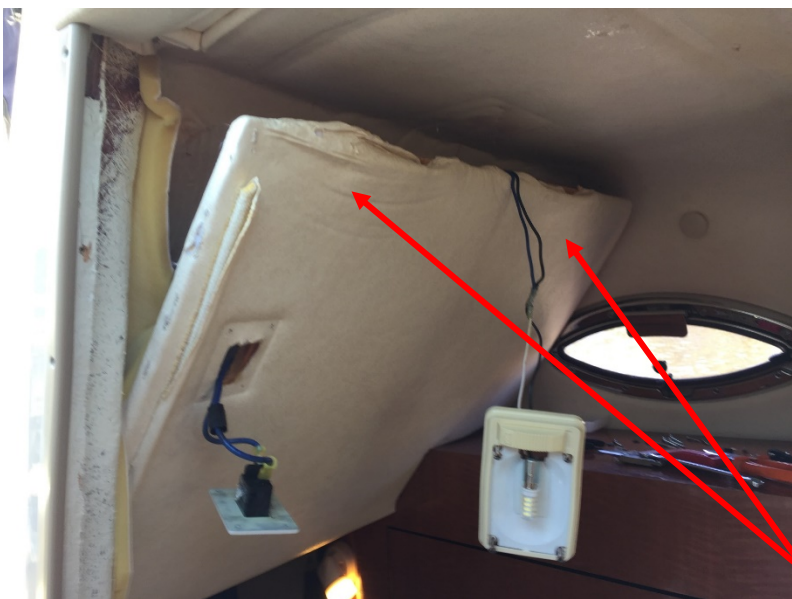
Now the fun begins. The trim panel with the light switch has to be moved forward to access the bolts/nuts for the seatback.

SeaRay assembles this part with two large screws that secure the panel to the fiberglass/plywood panel behind it. Looking closely while pushing the headliner up, you will see two red lines marked.

These lines show the approximate location of the sheet metal screws that are hidden behind the headliner on the panel.

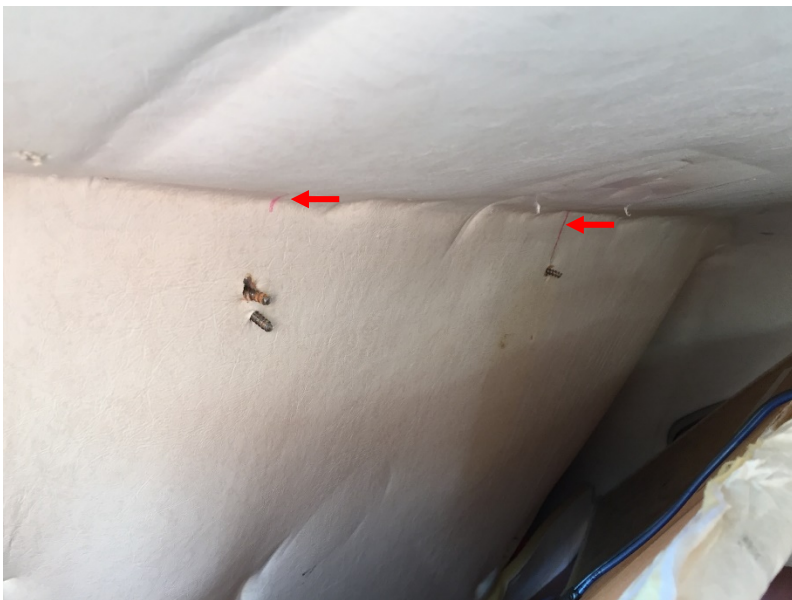
You must pull out the headliner that is tucked in to access the screws.

I had to use an impact driver to try to break the rightmost screw loose, the head twisted off.

The two screws on the left are from assembly at Sea Ray. Both heads were twisted off, just the threads were securing the panel. It pulled loose pretty easily.

Once these steps are completed, you will have access to the through bolts that secure the seatback. There are three at the bottom of the seat and six along the top.

NOTE, the three forward facing top screws (behind the interior panel with the cabin light switch) were bent over 90 degrees to clear the interior panel. I used a pair of pliers to bend them back straight.

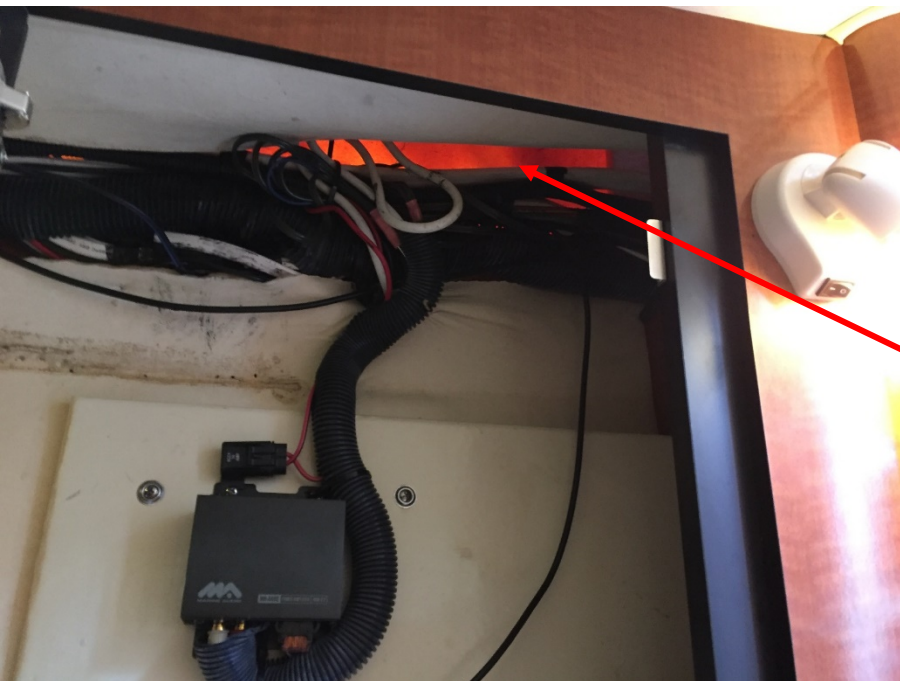
Access the rear most bolts from here. A 7/16" deep well socket is all you need.

I would highly recommend an air ratchet or electric ratchet as you can only move 2-4 clicks at a time with a conventional 3/8" ratchet.

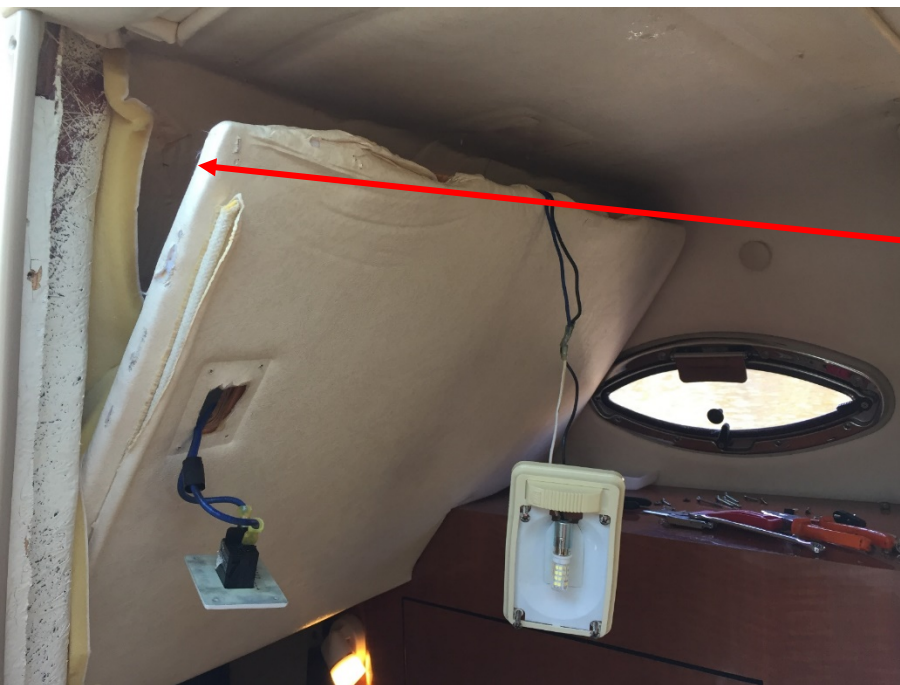
Access the forward most bolts underneath this panel. You will have to slice the headliner (non-visible areas) with a razor blade to access the nuts and washers.

The bolts that were bent over and straightened all twisted off. There are enough threads left to re-use for mounting.

NOTE – There was NO sealant used at the factory!

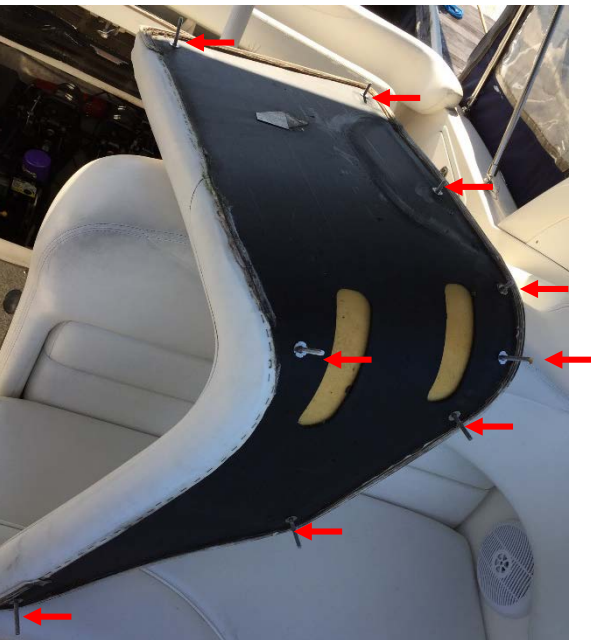
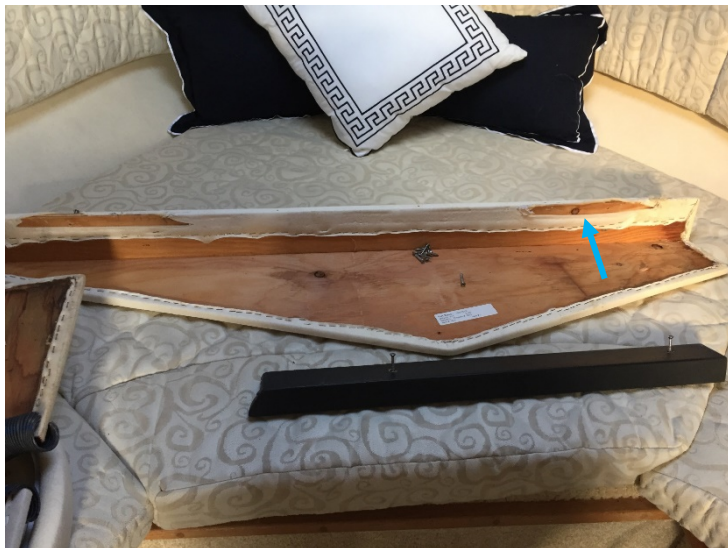
The images here are of the removed seatback showing bolt locations. When removing the rear most nuts via the aft berth cabinets, be sure you are on the correct ones for the seatback. There are nuts for the other cushions nearby and easily confused.

Also, on the vertical trim (blue arrow) I remember having to pull some staples for bolt access. I am away from the boat now and don't remember exactly why, but it was not a big deal. There are seven screws and a snap/screw combination holding it in place.

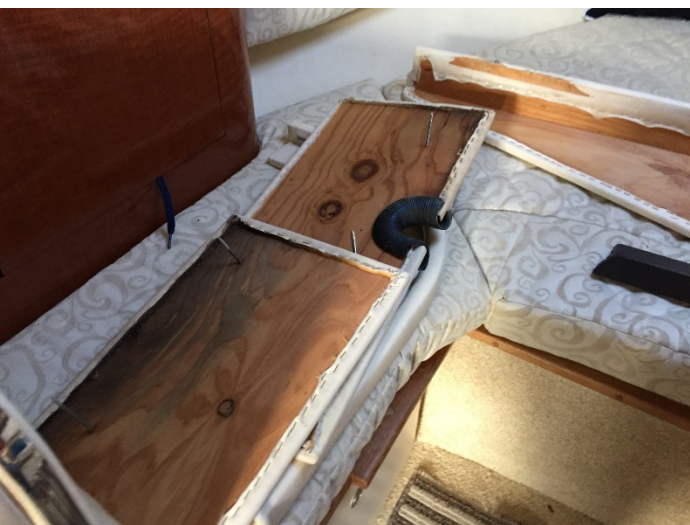
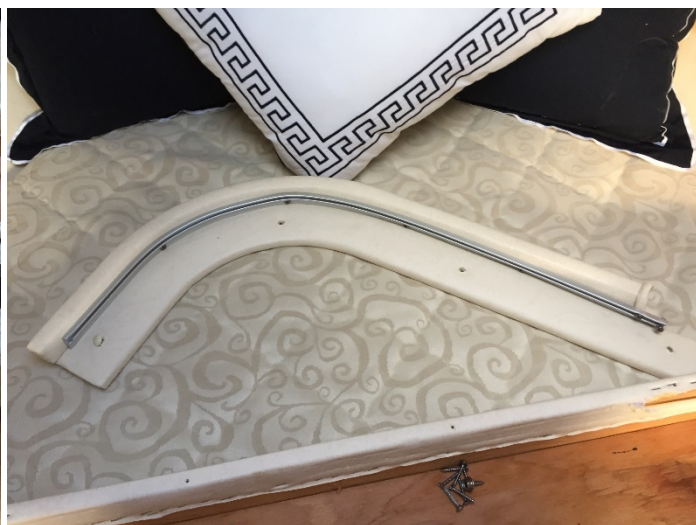
Below are the trim pieces from the rear berth cabinet. I pulled both sections behind both doors. Only the forward most piece (the smaller one in front) needs removed.
